## Correct position of the extraction arm – overview

### WALL-/CEILING MOUNTED ARM

## Correct position of the extraction arm

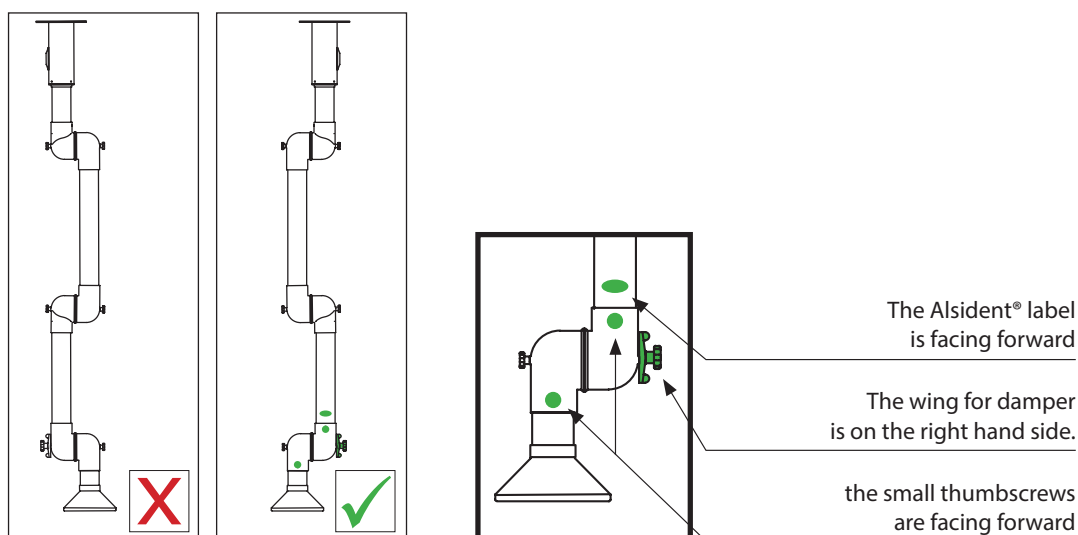
#### Quick check for correct positioning

We recommend before use to check that the extraction arm is mounted correctly. Incorrect mounting may affect the flexibility of the extraction arm.

One of the consequences of an incorrect mounting is that the spring will not come into function and the extraction arm will therefore sink from the intended working position. Through time this will cause the spring to loose its strength irretrievably. To re-establish the correct function of the spring, it will need replacement.

Changing an incorrect mounting of wall- og ceiling mounted extraction arms requires a demounting of the extraction arm.

The internal spring will be damaged by turning the extraction arm down backwards below the bracket and socket pipe. The extraction arm has to be demounted from the bracket and reversed UP above the socket joint.
